Report on the Investigation of the
lifting appliance accident on board

BBC Atlantic

alongside in the port of Antwerp, Belgium

19th October 2008

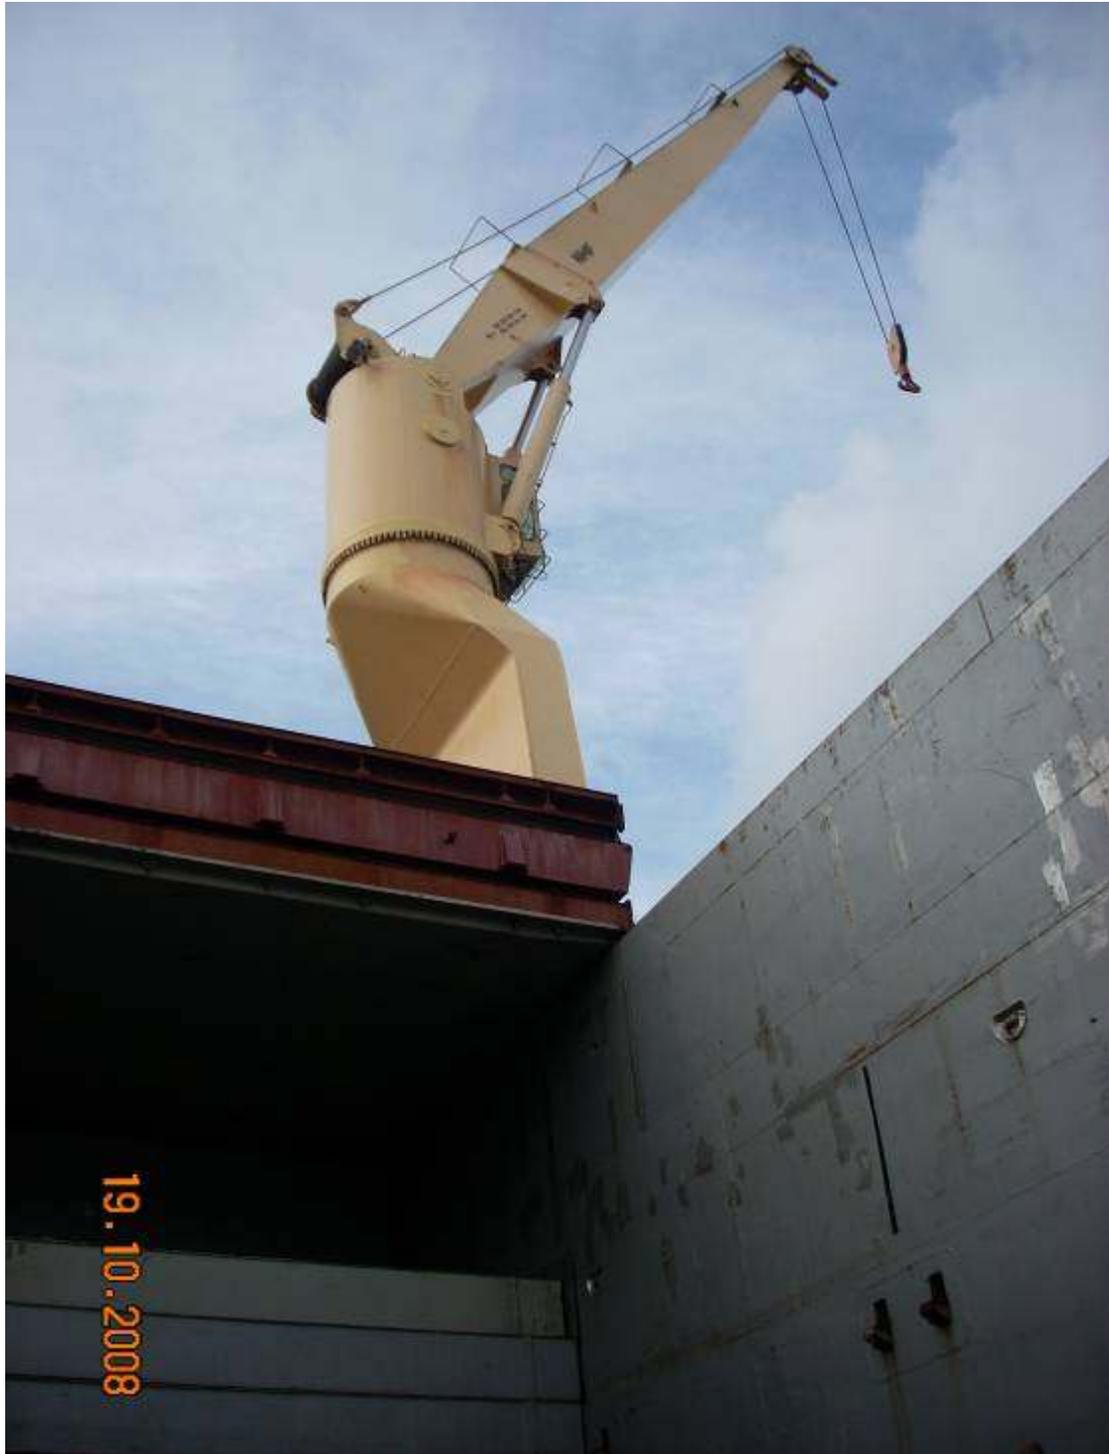
Figure 1. View of port forward cargo crane used during the accident (view taken from the cargo hold tank top looking aft), three of the tween deck hatch covers and two of the supports upon which the hatch covers rest on the side of the hold are also visible.

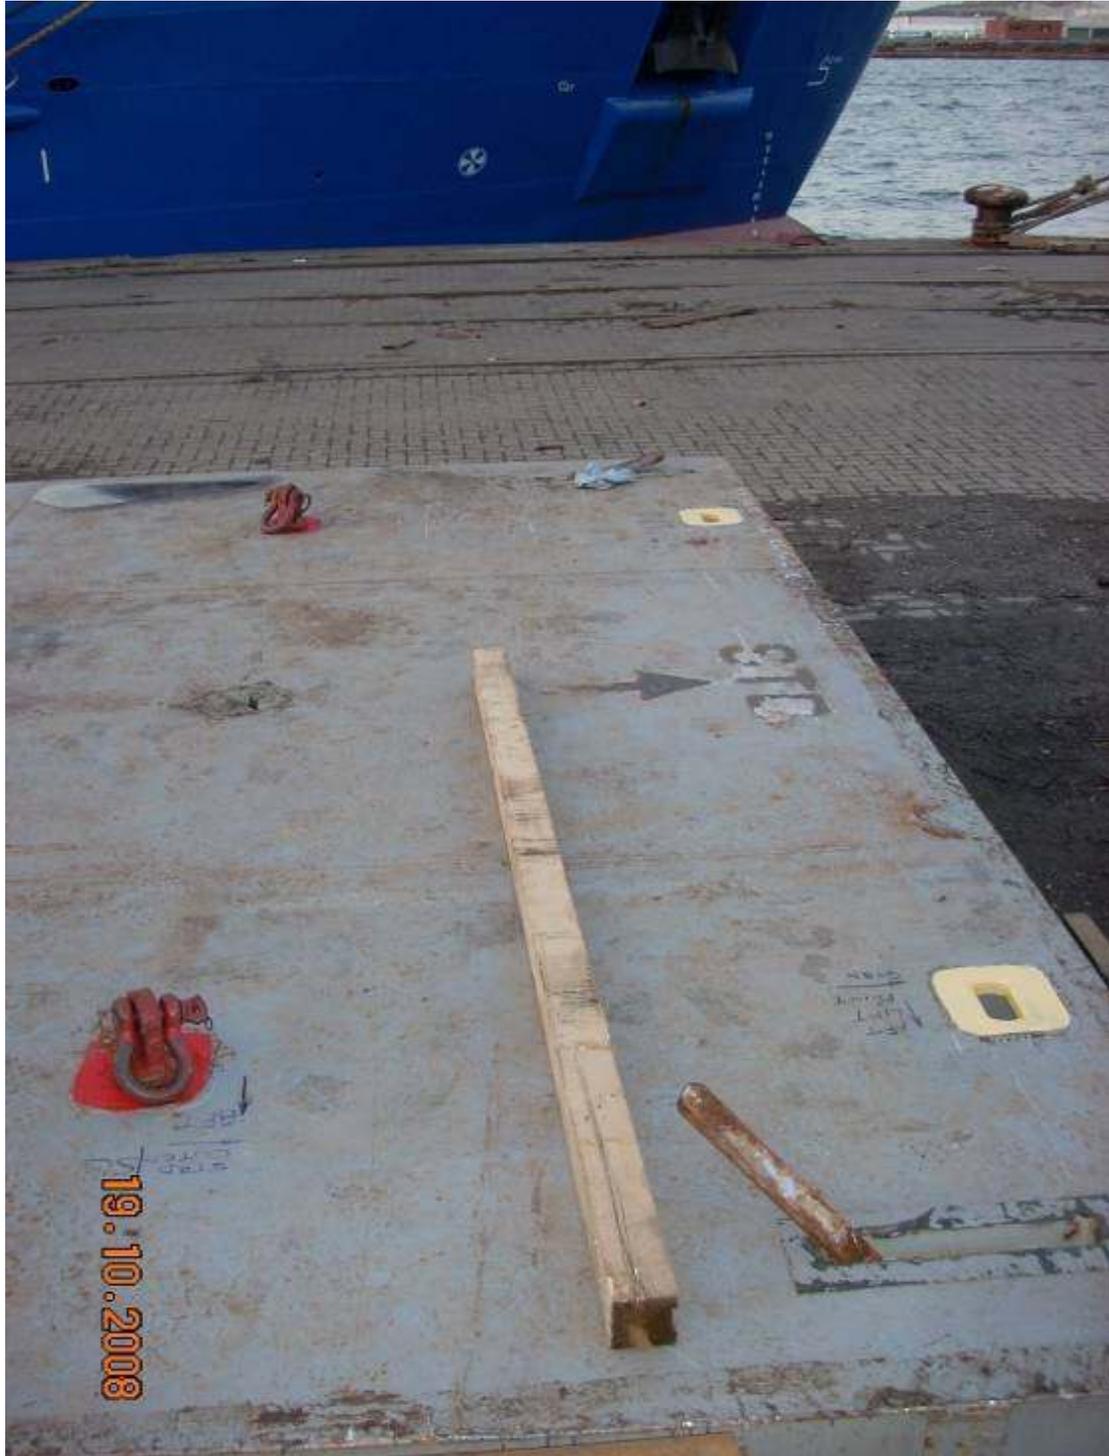
.7 Each pontoon hatch cover had as part of its construction eight container castings welded into the top plate, aligned in a longitudinal direction, four castings that were intended to be used for lifting the hatch cover, located at the outer corners. Four additional casting were located approximately one meter inboard of the lifting point castings with these inner castings intended to be used for the fitting of stacking cones to permit the hatch covers to be stacked on top of each other.

Figure 2. View of tween deck hatch cover pontoon landed ashore following the accident showing the two outer and two inner container castings on the starboard side of the hatch cover, the T hooks are shown inserted into the inner castings and aligned as per the lifting operation using the cargo crane. (N.B. the painting of the container castings in different colours was carried out after the accident as an interim recommendation during the investigation onboard).

1. Following discussion and recommendation during the accident investigation onboard the vessel the company undertook measures to reduce the risk of visual miss-identification of the container castings to be used for lifting the tween deck hatch covers. The outer container castings were painted yellow and marked 'Lifting Point' and the inner container castings were painted red and marked 'Stacking Cone Only'. The lifting hook of the hatch cover gantry crane was also painted yellow to match the colour of the lifting points.

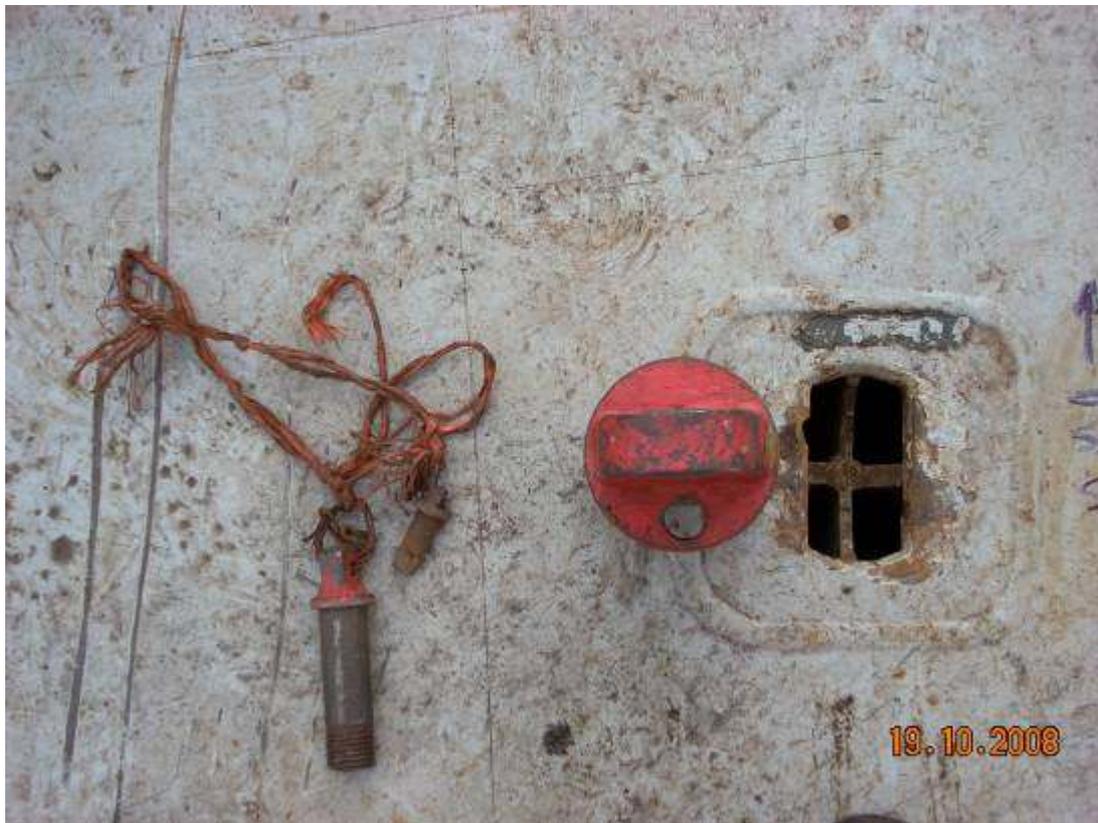
.8 This was confirmed as accurate following the accident by visual examination of the hatch cover castings where it could be observed that deformation had occurred to the plate edges of the inner castings when the T hooks had been torn out of the castings as the hatch cover fell.

Figure 3. View of inner container casting showing deformation of the plate edge caused as the hatch cover released from the T hooks, the circular indent to the plate edge is from the locking pin (smaller diameter pin shown) of the T hook.

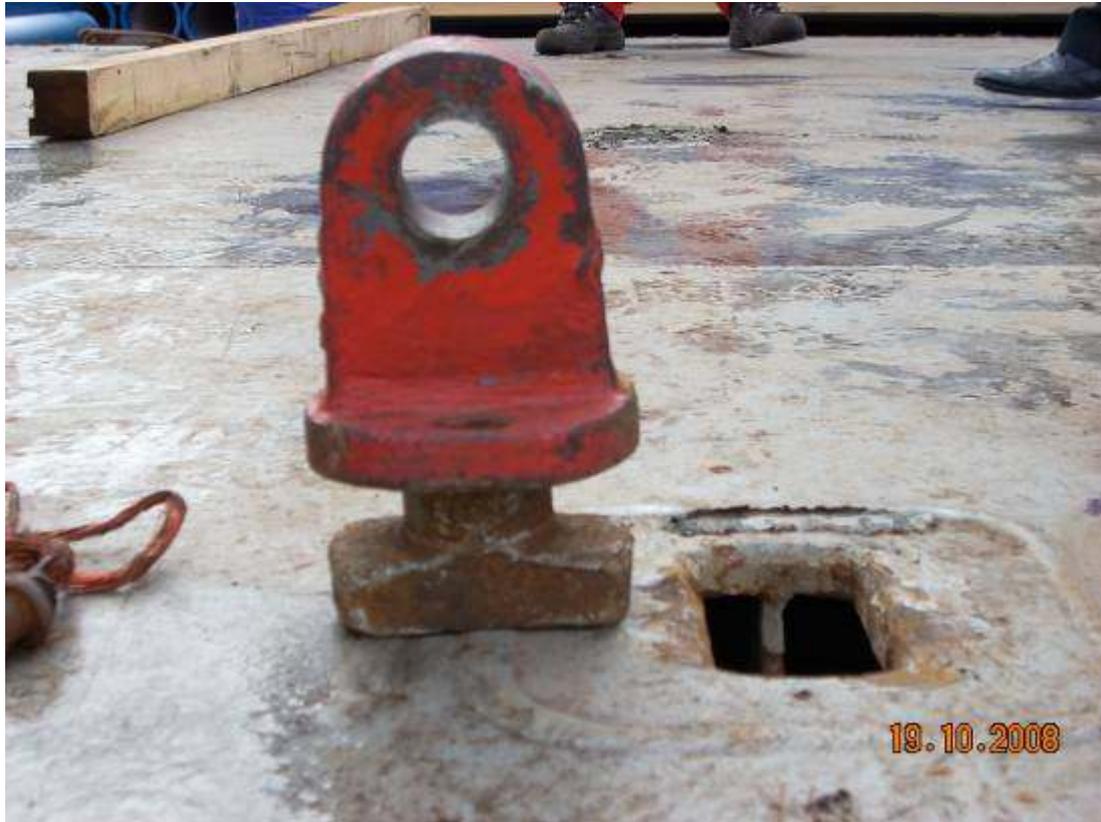
.1 The lifting wires from the crane were connected via shackles to the T hooks which fitted into the container casting and were turned 90 degrees so the lower portion of the T hook was then transverse to the hatch cover. A locking pin was supplied with the intention being for this pin to act as an anti-rotation device for the T hook during the lift by contacting with the inner transverse structure of the hatch cover in way of the container casting.

Figure 4. View of T hook shown next to a container casting in the position it would be in relative to the casting during a lift if correctly turned 90 degrees.

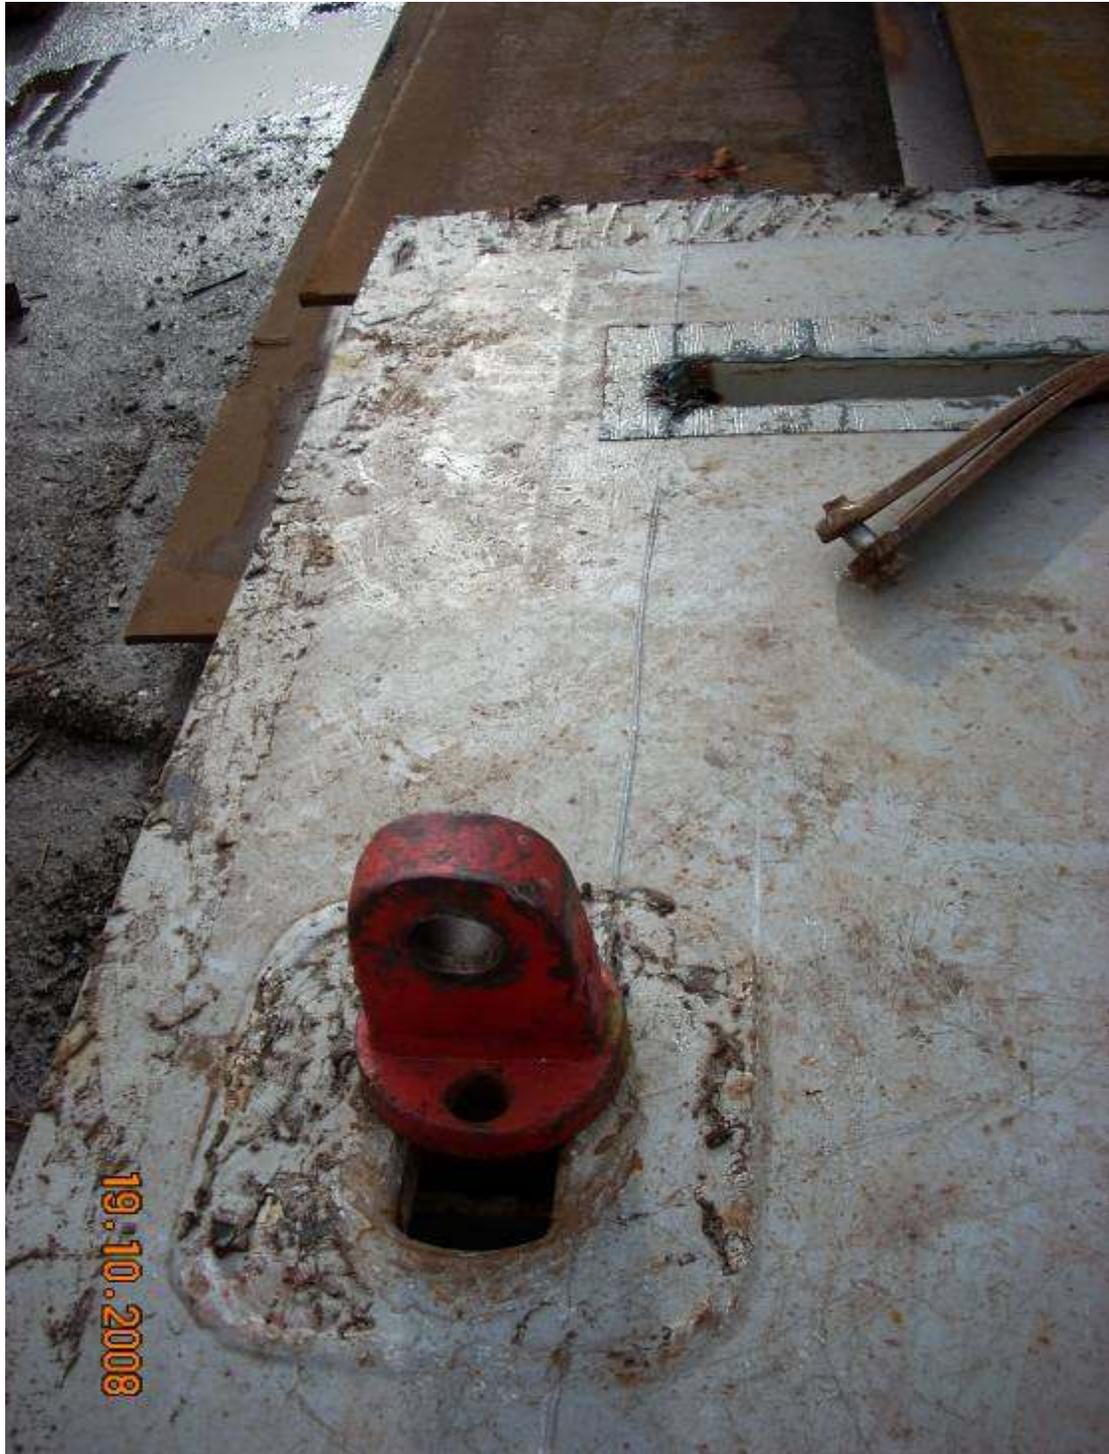
Figure 5. T hook fitted as intended in an outer container casting (lifting point) showing the hole for the locking pin, visible also is the inner transverse structure of the hatch cover upon which the pin contacts in order to stop the T hook from rotating during the lift.

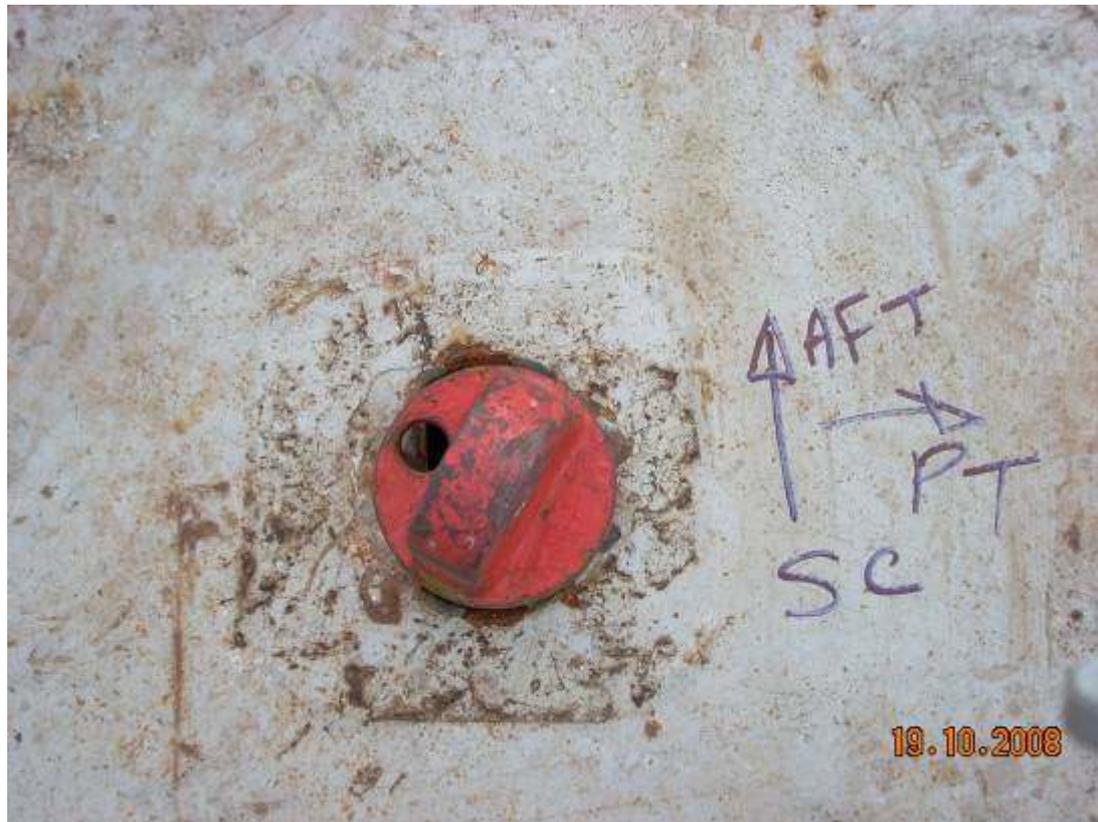
.2 During the investigation the T hooks were inserted into the four inner container castings intended for the use of the stacking cones as would have been the case during the accident. It was observed that in this location the T hooks could only be turned approximately 45 degrees due to the inner structure of the hatch cover at this location.

.3 Additionally due to the use of the cargo crane instead of the hatch cover gantry crane the T hooks would tend once under load to align toward the direction from which the load was being lifted, which in this case was at an angle toward the central crane hook.

Figure 6. View of T hook inserted into inner container casting and aligned toward the central lifting hook, the T hook is unable to be turned the required 90 degrees due to contact with the hatch structure below.

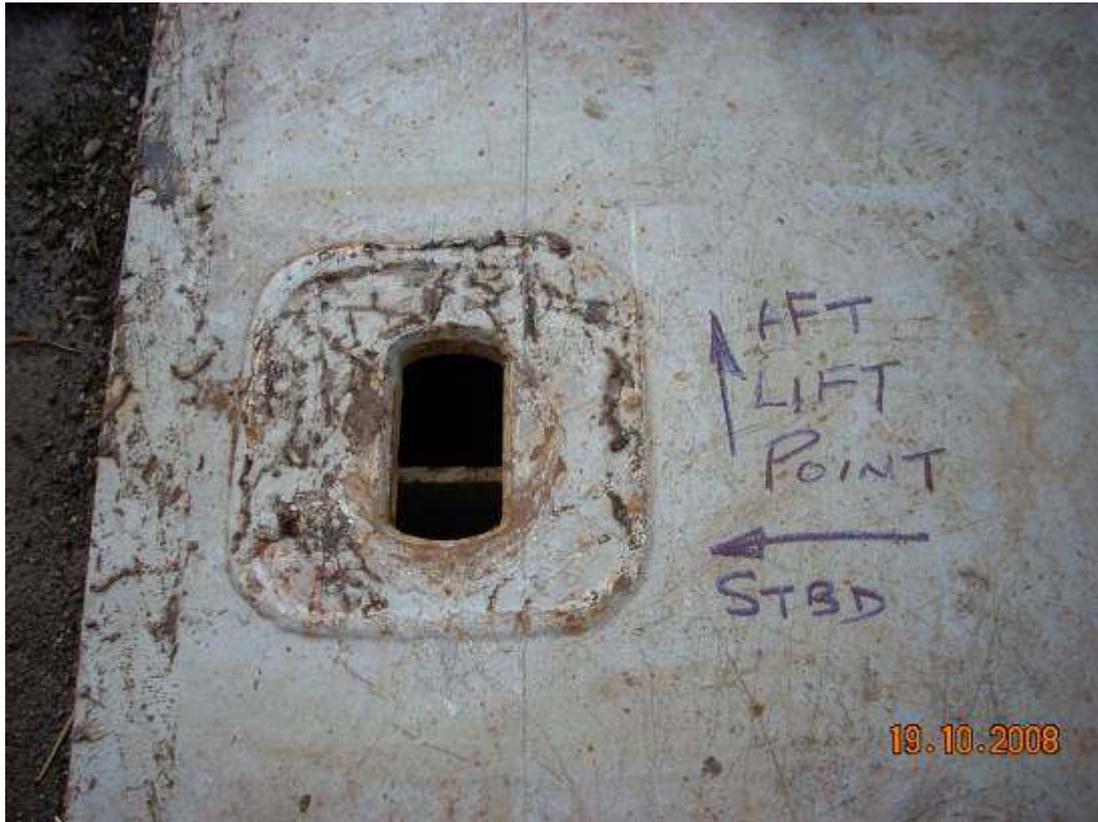
.4 Figures 7 and 8 indicate the typical difference between the internal hatch structure in way of the container castings, this difference being the reason as to why the T hooks could not be turned 90 degrees when inserted into the inner container castings.

Figure 7. View indicating an outer container casting intended for use as a lifting point.

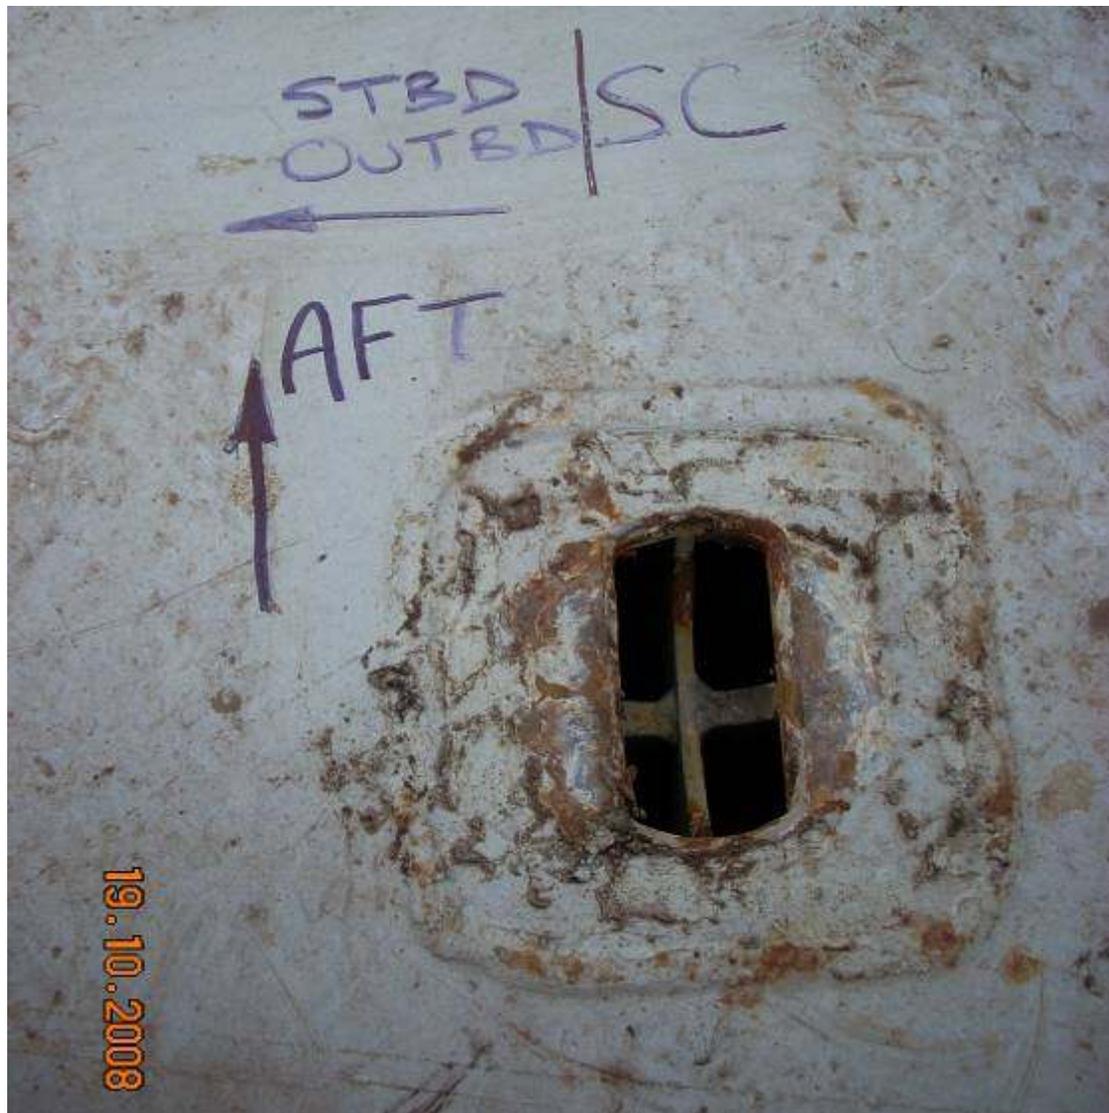
Figure 8. View indicating an inner container casting intended to be used with stacking cones.

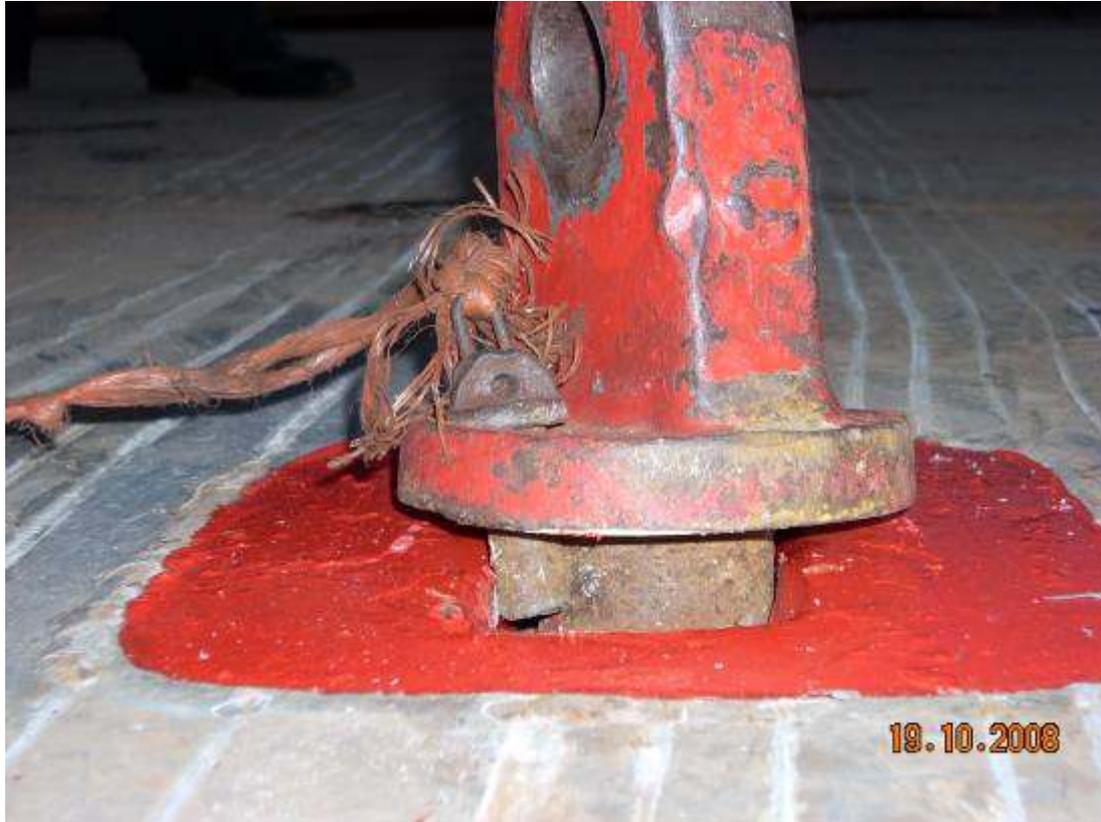
.5 As shown in figure 9 it was also noted that when the T hooks were fitted into the inner container castings the contact between the T hook and the hatch cover was poor with movement and clearances of such a nature that the locking pin could not perform any function in securing the T hook in position. The locking pin was considered not to be able to perform its intended function unless the T hooks were turned 90 degrees in the container socket.

Figure 9. View of T hook fitted into inner container casting as would have been the case during the accident indicating unsatisfactory clearances and locking.

4. The T hooks used onboard should be also be included in the colour coding system and painted yellow to match the outer container casting (lifting point).

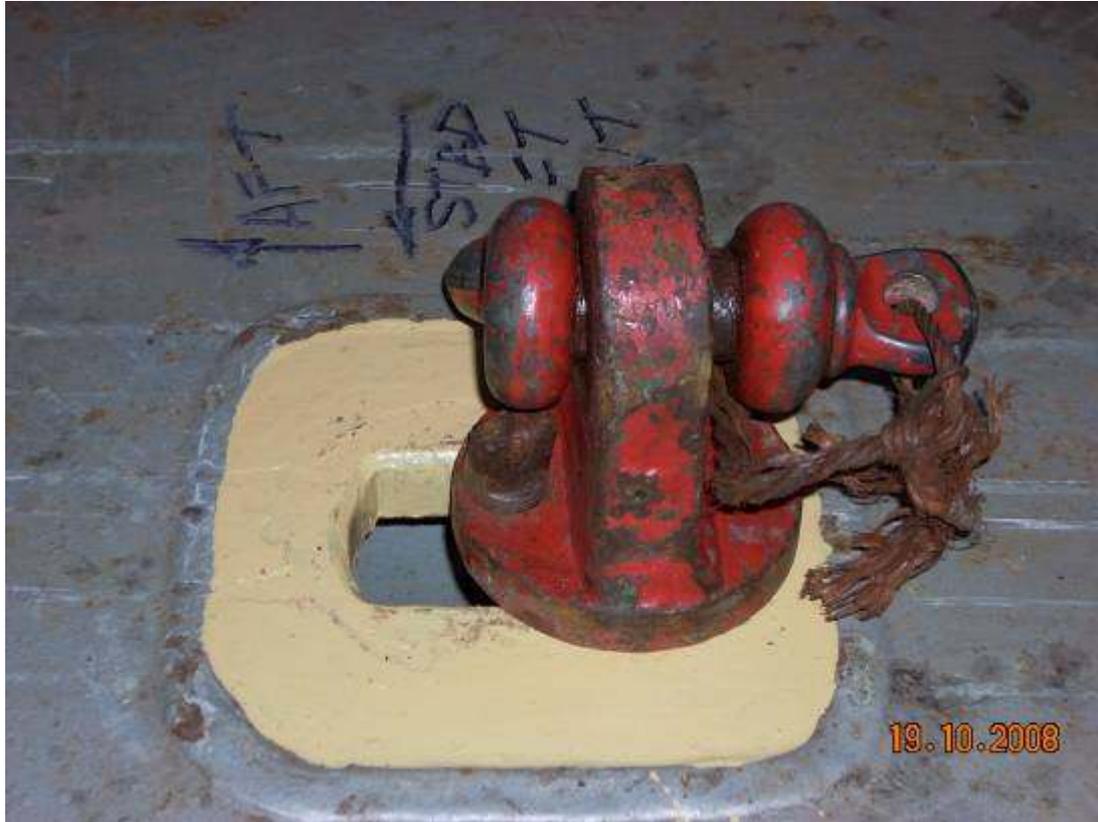
Figure 10. View of T hook fitted into outer container casting.

.6 Figure 10 shows the T hook correctly fitted into the outer container casting and aligned for a lift using the hatch cover gantry crane.

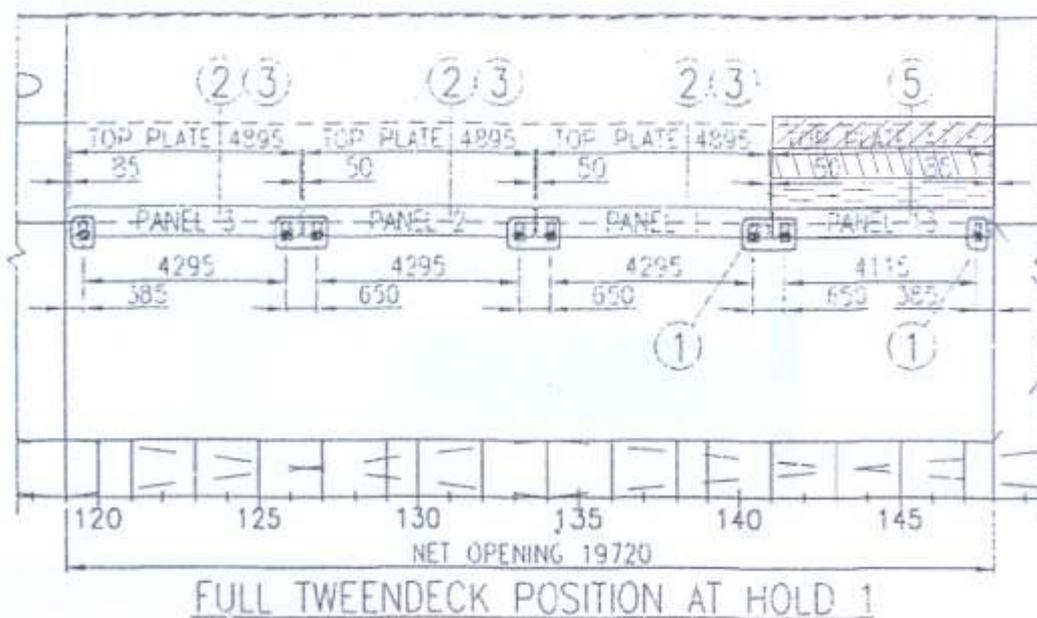
.1 At the time of the accident the four tween deck hatch covers in No. 1 cargo hold were stacked one on top of another at the forward end of the hold resting on the tween deck supports at that location. This temporary stacking arrangement was carried out in order to facilitate the loading of cargo onto the tank top at the aft end of the cargo hold.

.3 At the forward end of the cargo hold a protected ladder access was provided to both the tank top and tween deck. However due to the temporary stacking of the four tween deck hatch covers in the forward location on top of each other the protected access to the tween deck level was obstructed.

Figure 11. View of No. 1 cargo hold showing the four tween deck hatch covers stacked at the forward end of the hold in the position prior to the accident.

8. Ensure that tween deck hatch covers are stacked in accordance with manufacturers' recommendations with a view to eliminating potential falls from height during lifting operations.

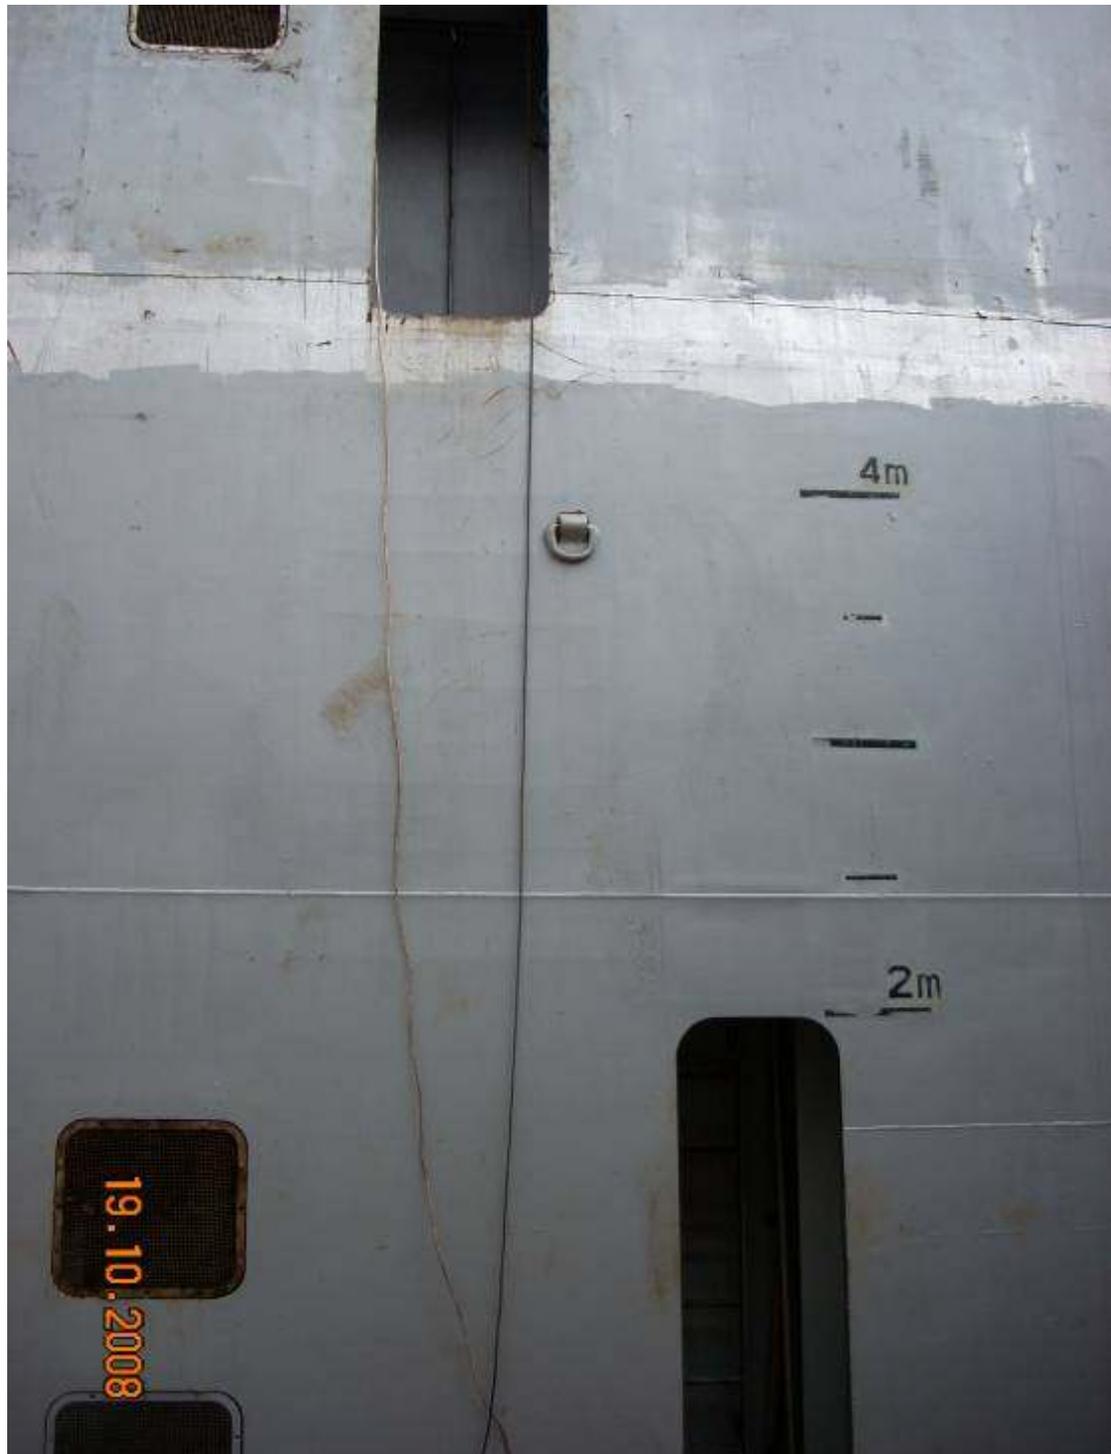
.4 The obstruction of the protected ladder access therefore facilitated the need for the C/O and OS to climb down to the tween deck hatch covers from the main deck using a portable ladder.

Figure 12. View of aft bulkhead of No.1 cargo hold showing the protected access to the tank top and tween deck levels, the lower tween deck hatch cover would have rested in the position shown with the lighter paint coating with the three remaining hatch covers stacked on top thereby restricting the access to the tween deck level.

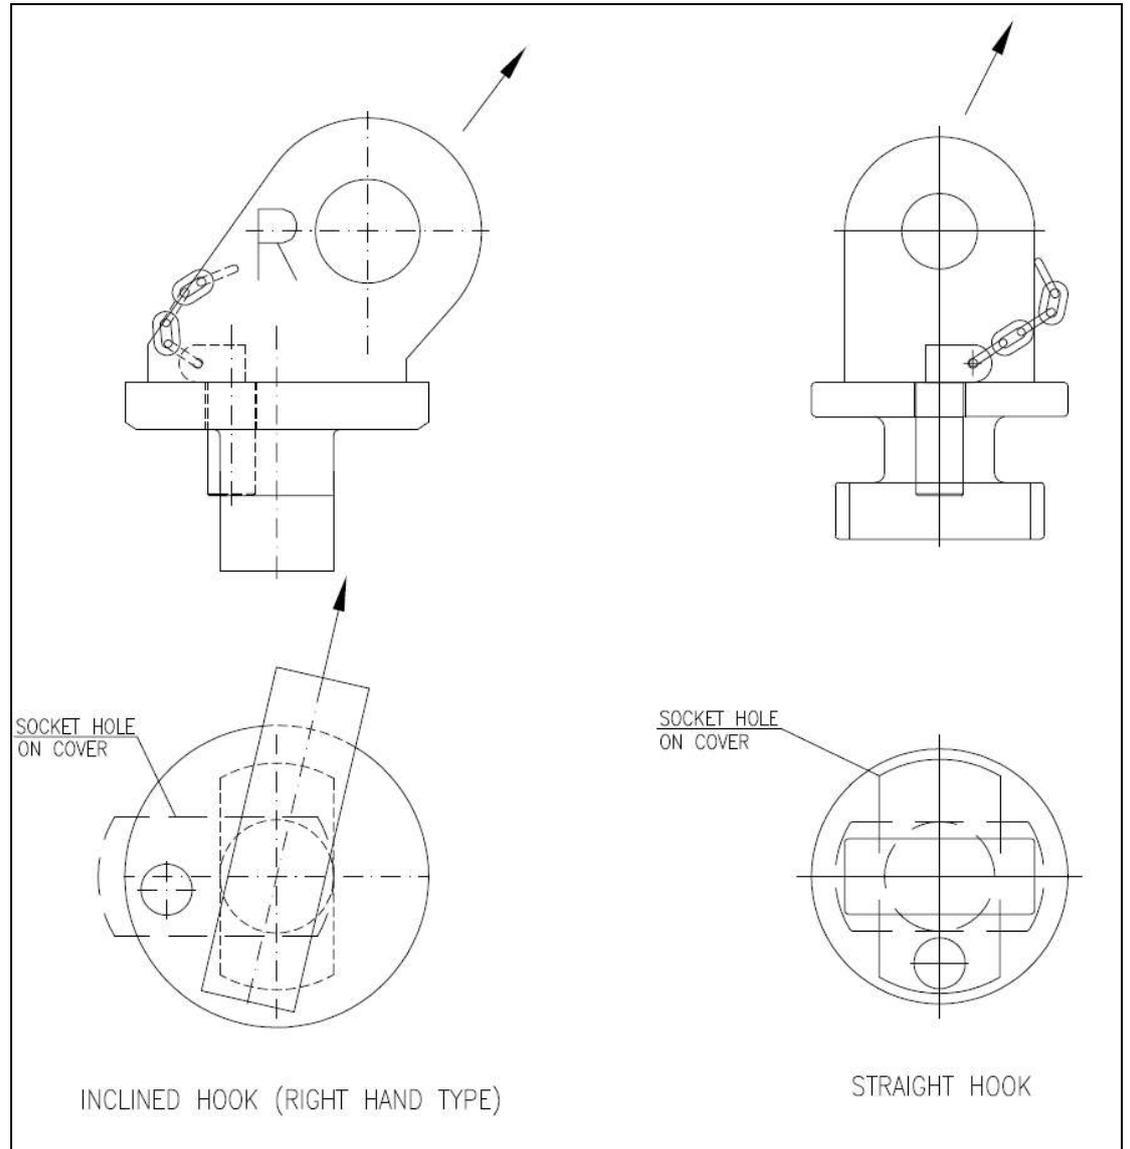
Figure 13. Sketch of inclined and straight T hooks (Mariners Ships Equipment)

.2 Mariner Ships Equipment designed a lifting arrangement following an inquiry from a shipowner for the lifting of tweendeck panels using a ships cargo crane. The arrangement required the use of an inclined design hook as opposed to the straight hook type used during the accident and intended for use with a vertical lift using the tween deck gantry crane (**figure 13**). It was however also recognised that a potential for confusion on the part of ships staff may exist with both inclined and straight hooks on the same vessel and that a spreader frame with connections at four corners to vertical wire ropes to the straight hooks could also be recommended.
