Report on the investigation of the accident on board

MV VIGOROSO

28th April 2009

This report is subject to the Gibraltar Merchant Shipping (Accident Reporting & Investigation) Regulations 2006.

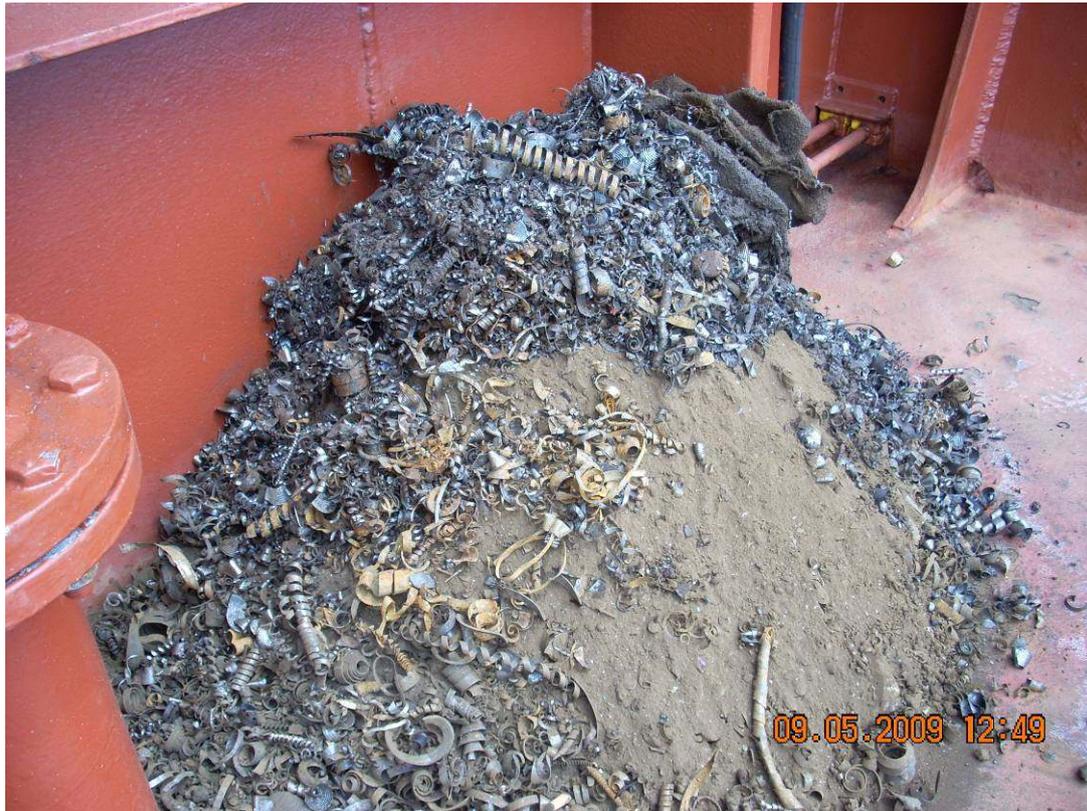
Cargo sweepings

- 1.8.7 The cargo was observed to "smoke" when the hatch covers were removed at the discharge port and the sample of hold sweepings showed evidence of rusting. It may be deduced from this that oxidisation had occurred after loading which would have significantly reduced the level of oxygen in the hold.

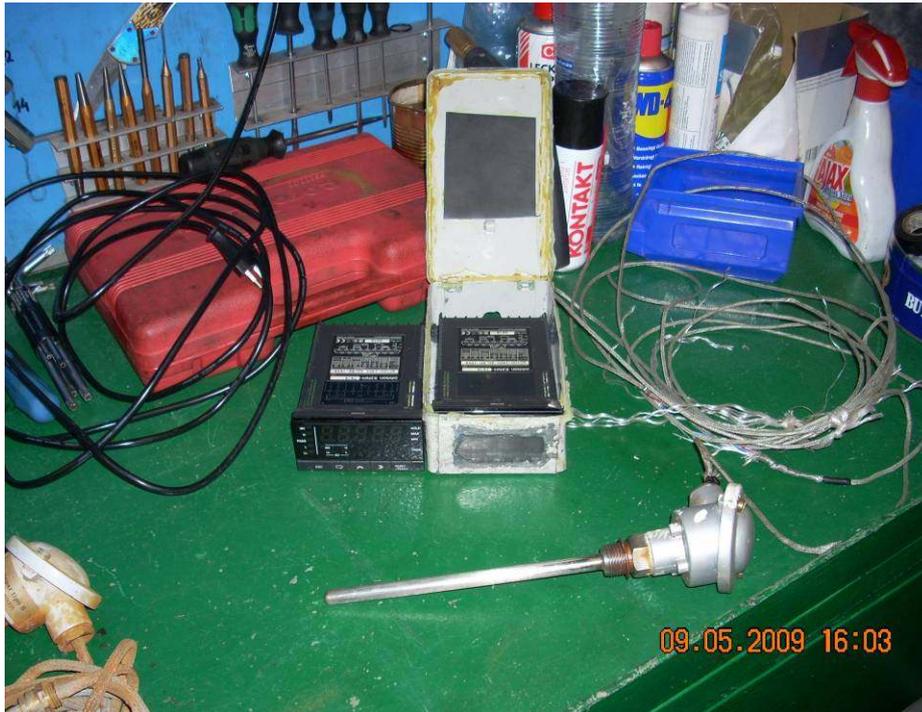
- 1.5.10 The cables from the sensor to the read-out displays were passed through the hold access hatches. These hatches could therefore not be fully screwed down tight without damaging the cables.

Temperature monitoring equipment.

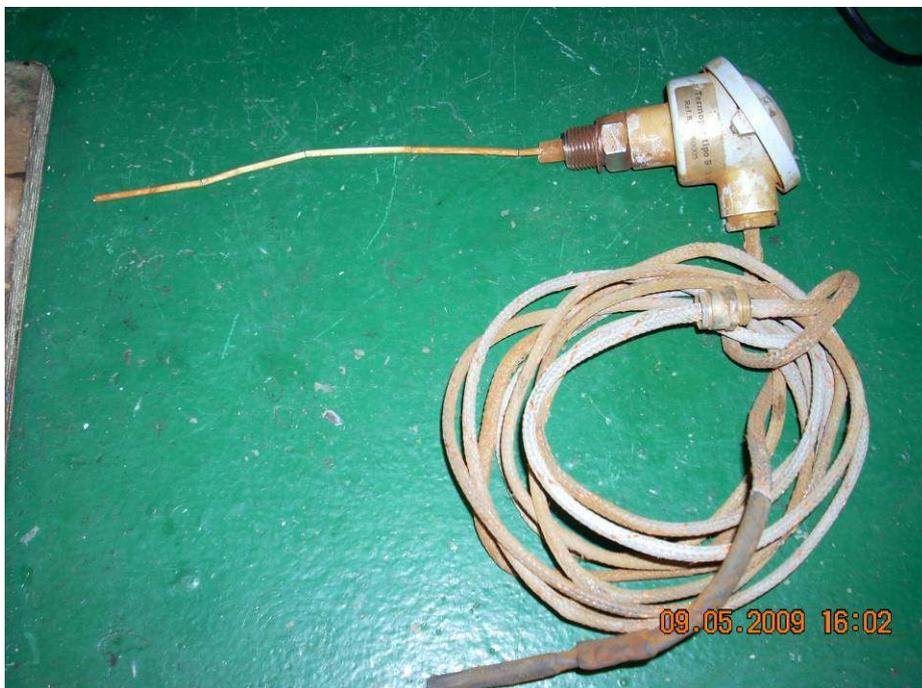
were opened and continued to “smoke” throughout the discharge operation. On completion of discharge, both temperature sensors were recovered. The sensor situated aft was found to be damaged.

Damaged temperature sensor

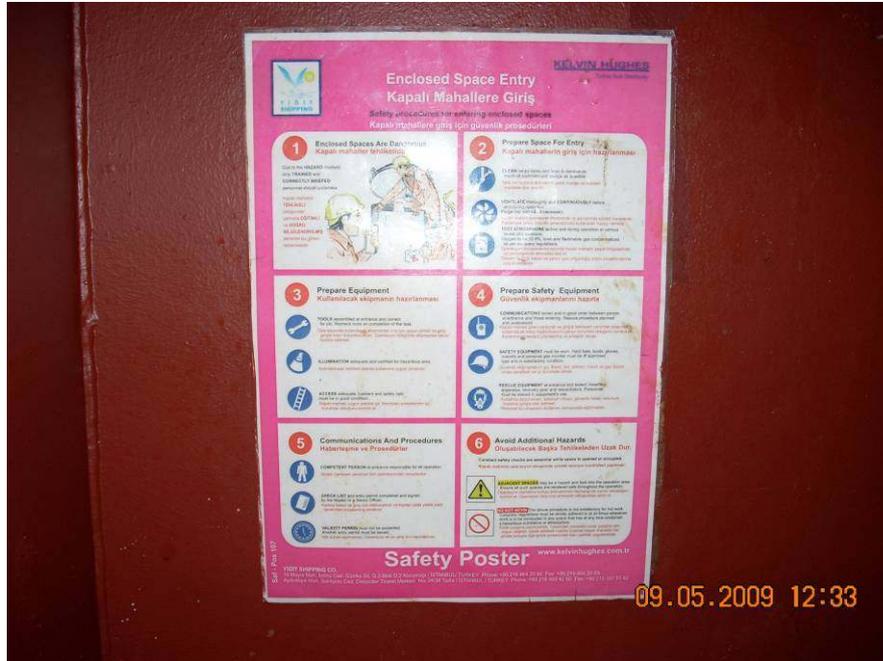
1.9.4 Signage regarding entry into the hold was displayed adjacent to the hold access hatches, fore and aft. Further notices were displayed on bulkheads in the accommodation.

Warning notice at hold access hatch

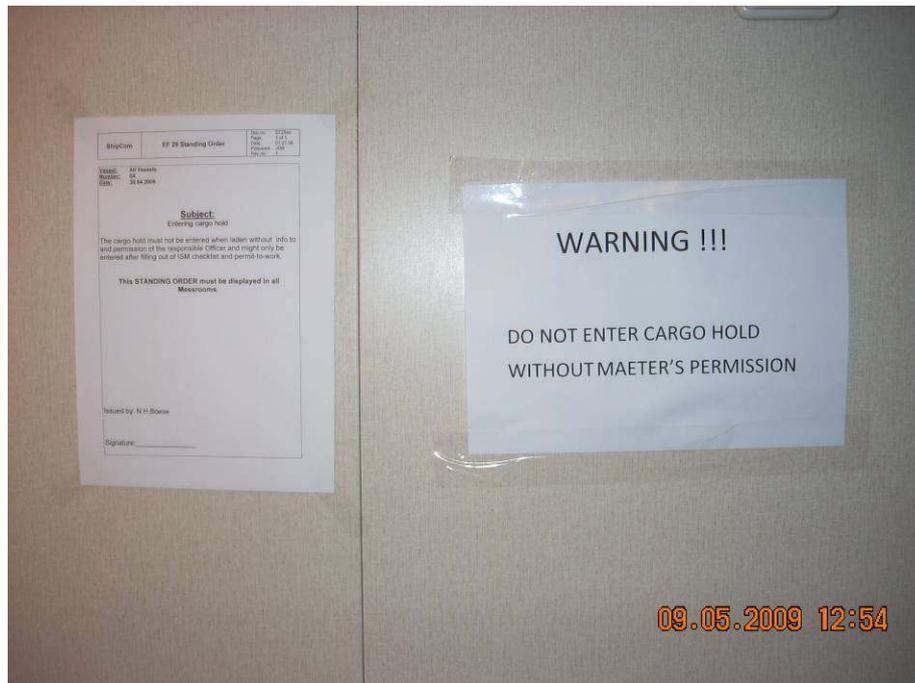
1.9.6 The Master discussed the nature of the cargo and associated dangers with the crew and posted signs in the messrooms prohibiting entry into the hold without his permission.

Warning Notice in accommodation

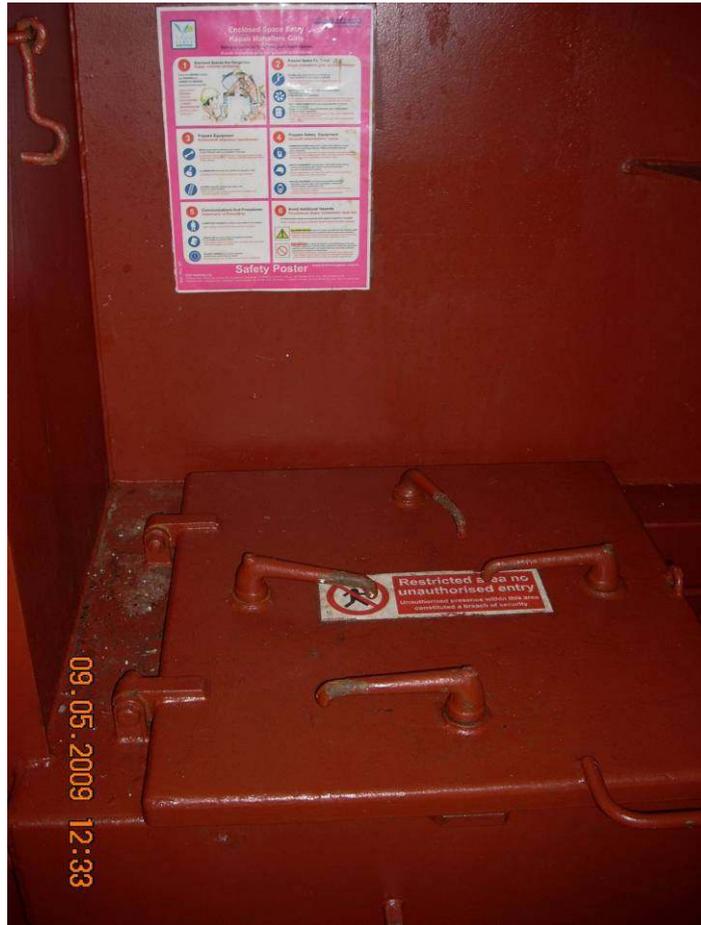
Aft hold access hatch

1.9.5 The hold access hatches could not be dogged down completely because of the temperature sensor cables. The access hatches were not marked with tape, tie-wraps or anything similar to make them more conspicuous and so alert the crew to the danger or to make it more difficult to open them.

- 4.1.1.1 Identify all dangerous and potentially hazardous spaces on board their vessels. [1.9.5]
- 4.1.1.2 Identify means to prevent access to potentially hazardous spaces [1.4.5]
- 4.1.1.3 Ensure appropriate procedures and equipment are in place for the monitoring and recording of the temperature and atmosphere in cargo spaces as appropriate. [1.3.6, 1.3.8, 1.3.10, 1.3.11, 1.5.9, 1.7.5, 17.6, 1.8.2, 1.8.6]
- 4.1.1.4 Ensure that the responsibility for the provision of specialised equipment required for the carriage of potentially hazardous cargoes is clearly defined. [1.3.3, 1.3.5, 1.3.6, 1.5.9]
- 4.1.1.5 Ensure that the appropriate authorities are informed of serious accidents and incidents without unnecessary delay. [2.7.6]
