Report on the investigation of the Grounding Incident involving

MV VISNES

15 February 2015

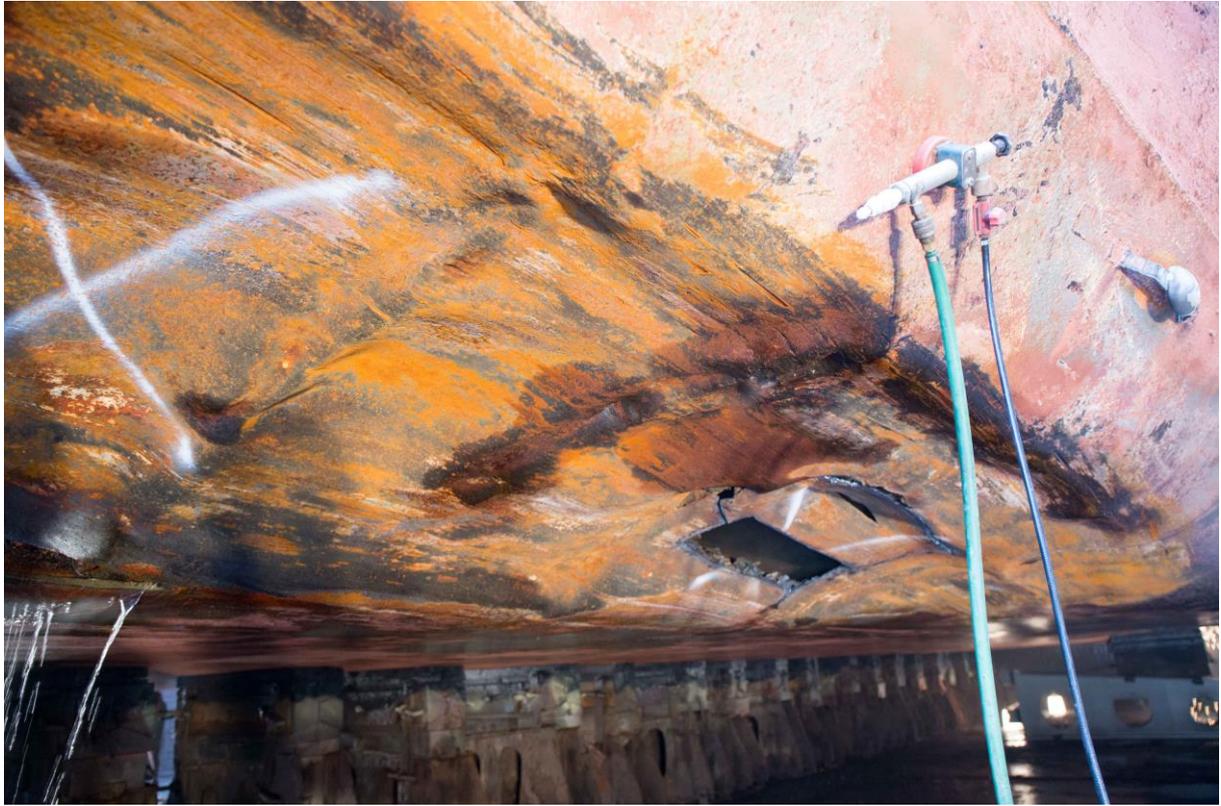
Photo Showing Major Damage

The level of damage viewed on the ship ´s hull indicates the vessel struck a hard, more than likely heavy object, which could not have been easily swept aside.

The bottom damage is as follows from BV Class: Quote

WB DB 3 SB **No damages.**

WB DB 3 PS, Bulkhead fr 58-46 (bottomplate), 300x400mm floor plate. fr. 46-47 krael.

WB DB 2 PS, fr. 73-88, bottomplate + 300x600 floorplate (bottom long. no 2 from bulkhead)
Kimiing plate, indent 72-70, 67-68

WB DB 2 SB, 87-88, bottomplate 300x400mm floorplate (just before turn of bilge) 73-65,
bottomplate, 300x400mm floorplate 2 pcs gasket piping.

WB DB 1 SB, 88-92, 300x400 bottomplate, 900mm from kimning towards center. hole in tanktop
towards wing side tank.

WB DB PS 1/Center, Cropped out 100mm long in damaged area. 1 Centr. PS, bulkhead/sludge tk,
50mm long crack long.

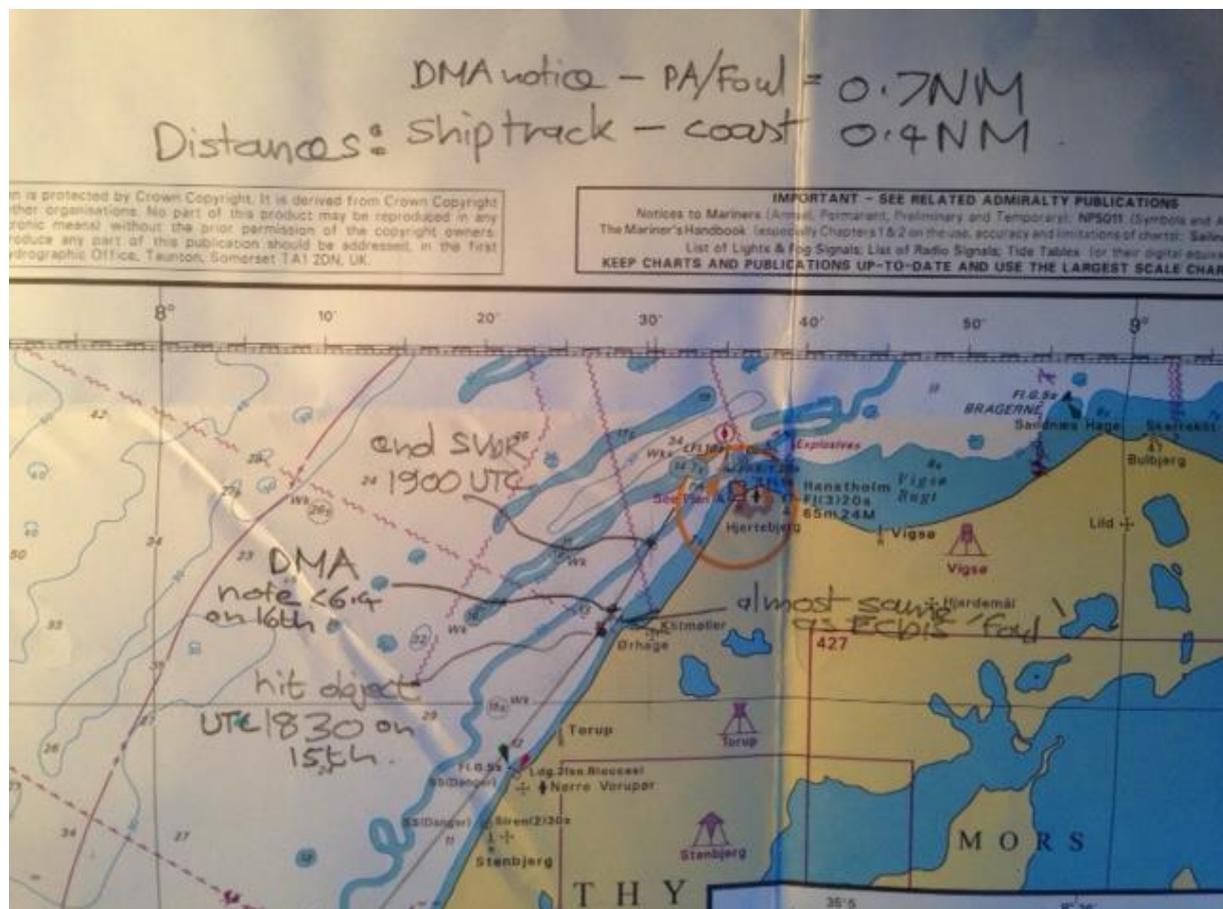
The point of contact given by the SVDR is exactly the same as the "foul" symbol on the ECDIS chart and the "#uneven ground symbol" on the paper chart BA1422 as shown below. The Danish notice of restricted draft on the 16th February is shown approximately 0.7NM from the contact point.

The course was made very close to the coastline and at the point of the incident was measured at 0.4 NM.

There was no warning on the chart of restricted water depth other than the symbols used for foul/uneven seabed at the point of contact.

The passage plan routed the vessel over the foul/uneven seabed position. Further the plan was too close to the shore and did not consider the space required for COLREG requirements to turn to starboard in the event of a potential head on collision (only 0.4NM to land). Finally the DMA considers this area not an international shipping route, as it does not provide NAVTEX warnings for the area.

Eighteen hours after the contact, the Danish Maritime Authority (DMA) reported the Klitmoeller water depth was down to 6.4m at 13:08 hours on the 16th February. That warning is at a slightly different location from the contact made, but by only 0.7NM. Based on the draft of the vessel and the proximity, it is fair to say that it was at least a likely the source of underwater contact.

- 1) **The Company** is to implement a system on monitoring and checking of vessels passage plans, incorporating strict guidelines including :-
 - (i) Position fixing intervals.

- (ii) Safe clearing distances
 - (iii) Appreciation of the effects of squat on a vessel's draught.
 - (iv) Navigational hazard high-lighting.
- 2) **The Company** is to submit the remaining requirements to GMA in order that the system of ECDIS can be approved for use as the primary means of navigation
