Report on the Investigation of the  
Failure of the hatch cover gantry crane on board

**CIMBRIS**

alongside in the port of Tekirdag, Turkey

4<sup>th</sup> April 2008

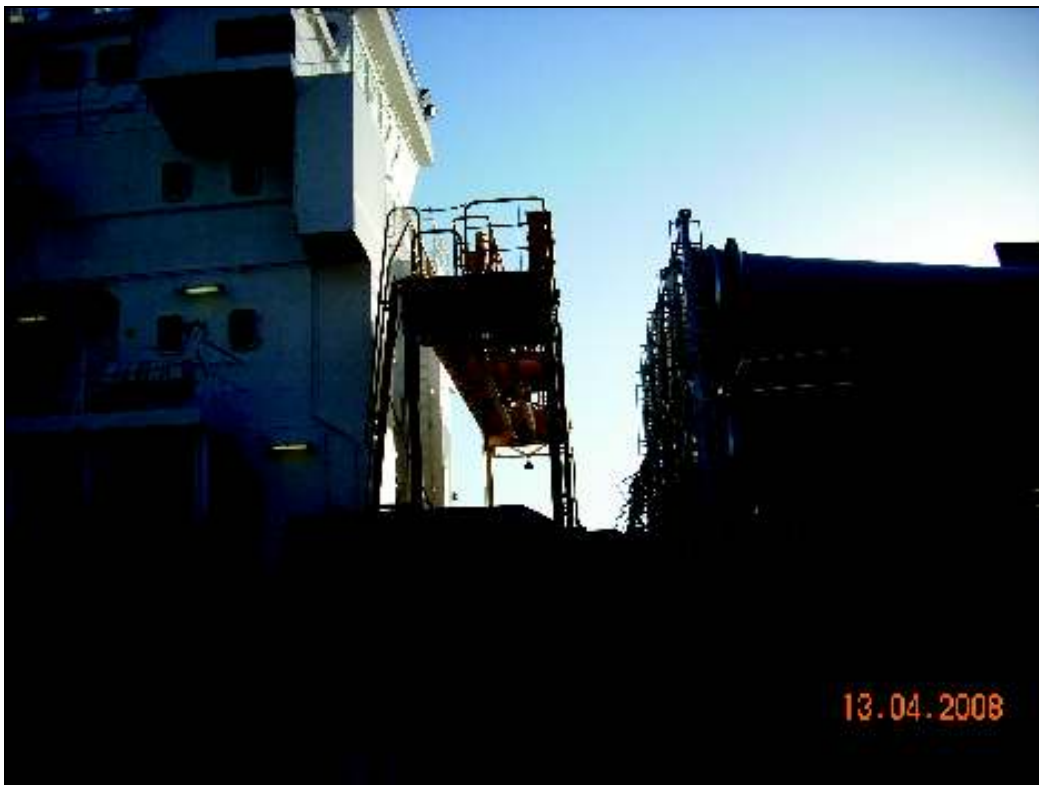
Figure 2. Side view of hatch cover gantry crane with the lifting frame in the stored position

The hoist wires failed at a distance of 4320 mm and 4440 mm from the end termination that connects the hoist wire to the main deck lifting frame or tween deck lifting beam. When the crane was not in use and in its stored position as per **(Figure 2)** the point of break would be approximately mid way between the hoist drum and the outboard sheave. The wire in the region of the break would therefore be subject to the weather when the vessel was at sea to a greater extent than the wire that was on the hoist drum.

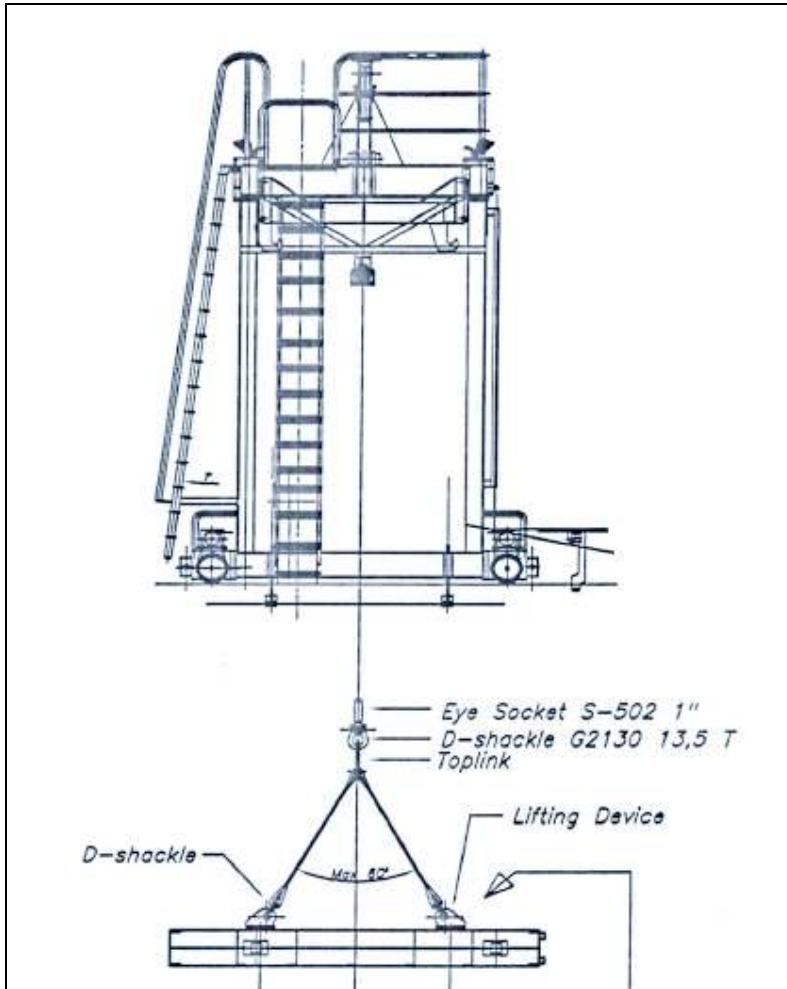
Figure 3. View of hatch cover gantry crane arranged for lift of tween deck hatch cover (as per manufacturers data provided onboard)

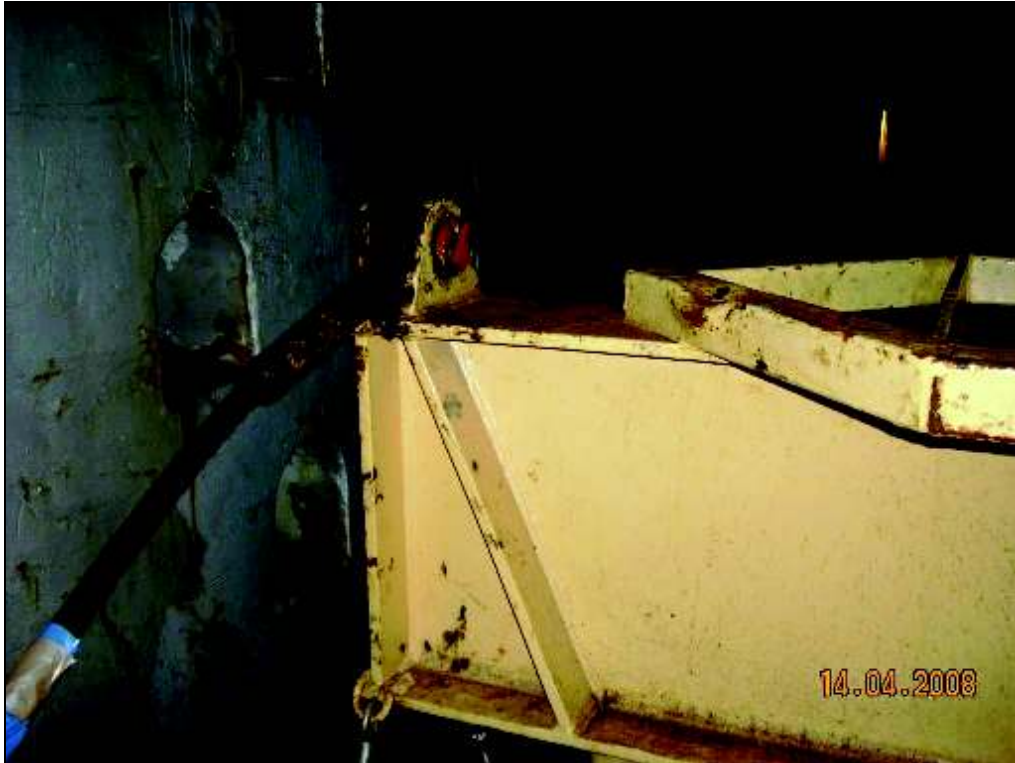
Figure 4. View of hoist wire connection at one end of the tween deck lifting beam

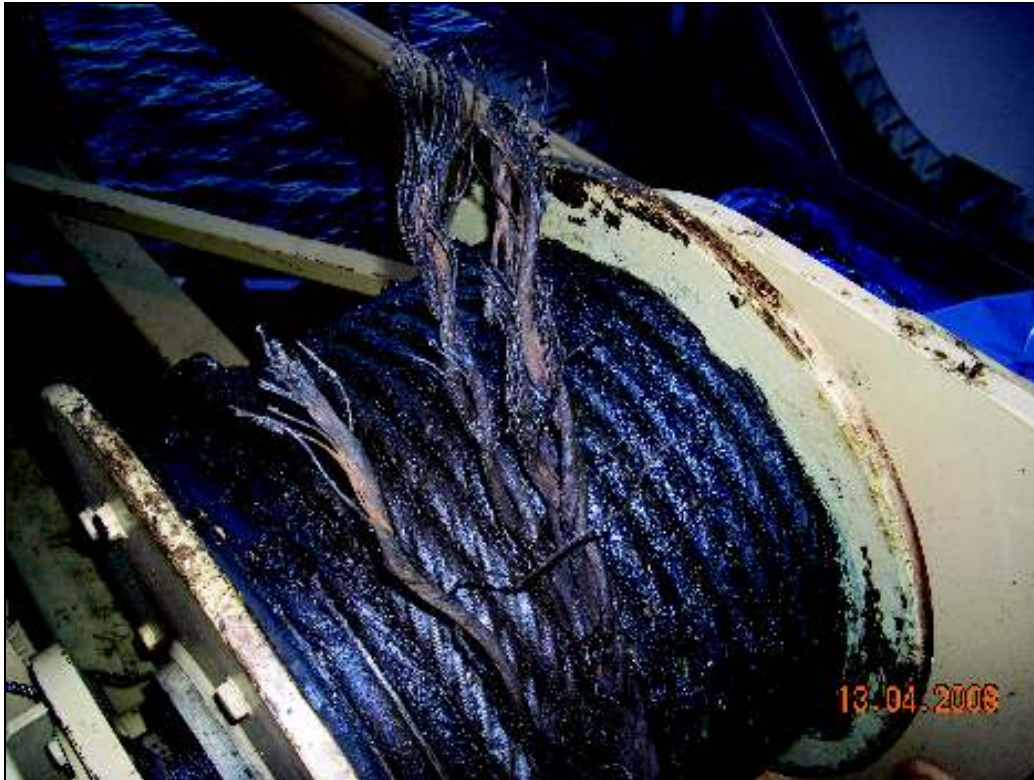
Figure 5. View of failed hoist wire at winch drum showing level of greasing present on wire during normal operation. Corrosion product is also visible on the de-stranded wires at the point of break.

.3 From examination (**Figure 5**) it was apparent that the hoist wires were not subject to cleaning to permit visual inspection as part of the maintenance procedures, with greasing likely to have been applied weekly onto existing grease. Insufficient attention with regard to lubrication would also have been paid to the less accessible locations such as in way of the sheaves.

.2 Unless otherwise indicated by the manufacturer, wire ropes should have the dressing of grease or oil applied during installation. This dressing should be cleaned and re-applied at regular intervals with particular reference to those lengths of wire that pass over sheaves. This removal and re-application of the rope dressing should be carried out in connection with a visual inspection of the rope.

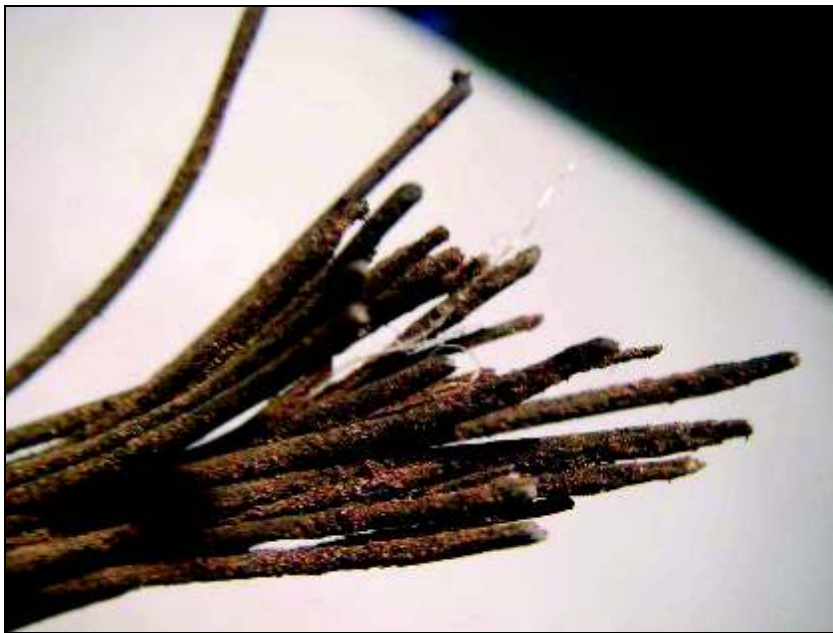
- Due to extensive corrosion the cause of a large number of wire breaks at the points of failure of the wires could not be established, the failed ends of the wire showed only a few remnants of lubrication at the outer strands and no lubrication could be detected at all within the rope, **(Figure 6)**.
- Fatigue wire breaks were observed at locations throughout the wire including the outer strands, the next Warrington layer and the outer strands of the steel core and the core strand itself. Fatigue fracture being generally associated with a wire that is worked around a sheave or drum, **(Figure 7)**.
- Forced ruptures of the core wire could also be observed which will occur when a tensile overload of a wire occurs. Several wires also displayed shear damage, which is indicative of additional perpendicular compression by neighbouring wires during a tensile overload condition.

Figure 6. Wire breaks at an outer strand at the point of failure of the wire.

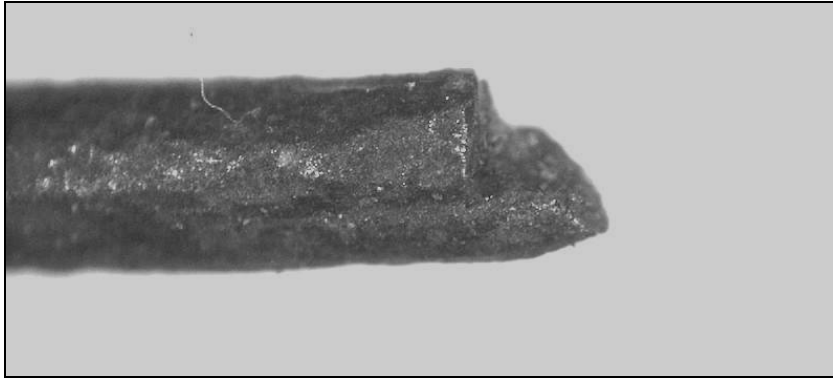
Figure 7. Fatigue wire break on a Warrington wire.

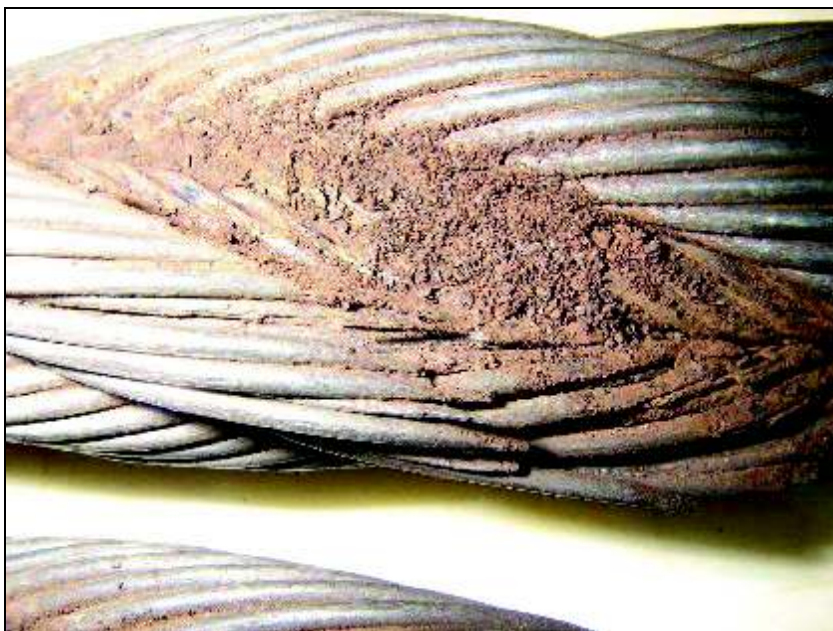
- A number of wire breaks were found in the outer wires of the outer strands, with the wire break ends displaying acute corrosion and the presence of corrosion remaining within the strand space of the wire. Corrosion was found to extend into the core wires of the outer strands, no internal lubrication was found, **(Figure 8)**.
- The outer strands in which outer wire breaks were found were de-stranded, following which wire breaks were also found in the thin and thick Warrington wires, **(Figure 9)**.

Figure 8. Wire breaks located next to each other in the outer strand of the wire adjacent to the points of failure with evidence of acute corrosion.

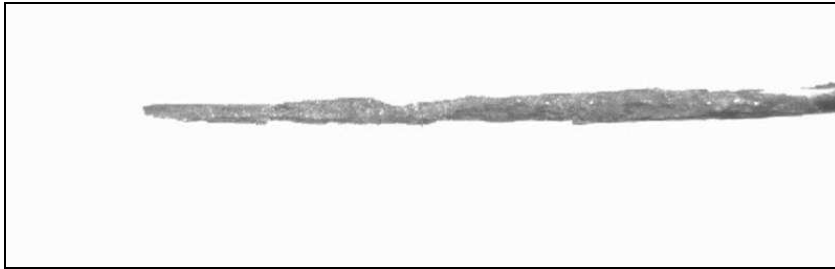
**Figure 9. Wire beak of a thin Warrington wire with tapered corrosion.**

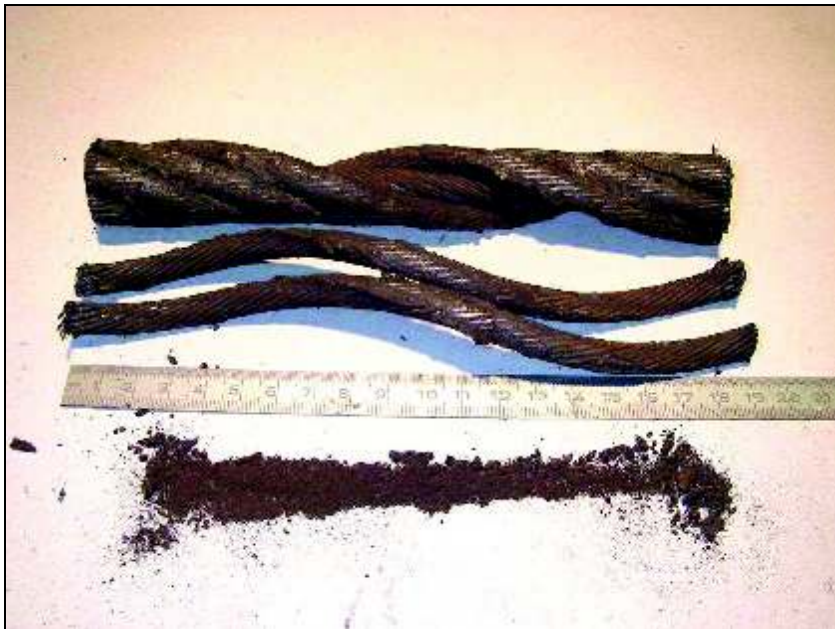
**Figure 10. Wire Rope specimen with two separated strands showing the level of corrosion product found within the rope during de-stranding.**

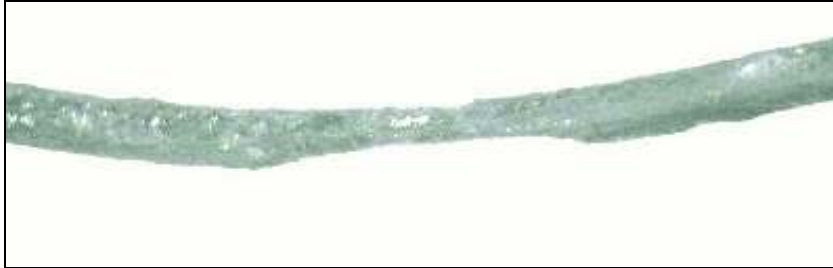
- Upon opening the steel core, wire breaks were found to the outer strands of the steel core and the outer wire of the core strand, **(Figure 11)**. Corrosion was also found to have extended to the steel core with the wires of the steel core showing abrasion and dents **(Figure 12)**. Only very sporadic galvanizing residues were found on the steel core wires.

**Figure 11. Outer wire of outer strand showing abrasion at the contact points as well as corrosion.**

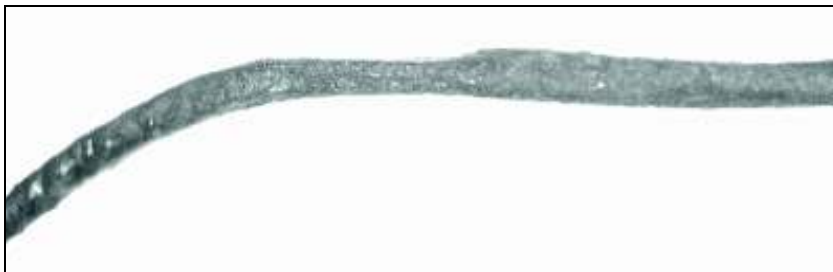
**Figure 12. Abrasion on a contact point on an outer wire of the core strand of the steel core.**

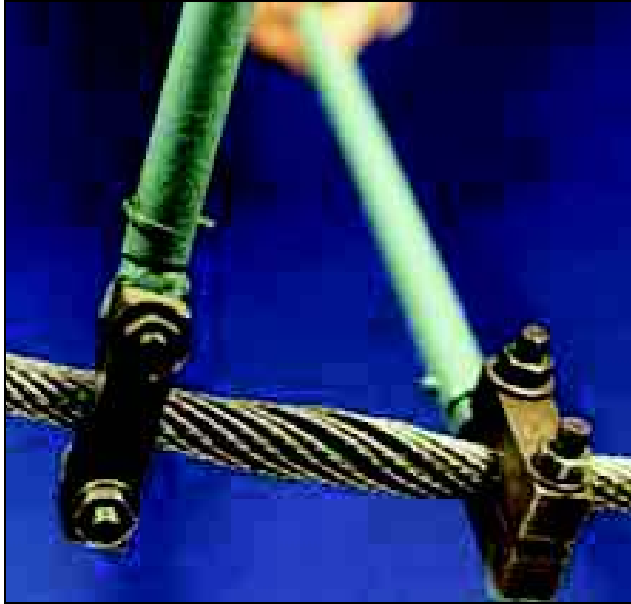
**Figure 13. Internal examination of wire rope** (Source: Certex)

.4 If during an examination there is any indication of possible internal corrosion the rope should be subjected to an internal examination by a competent person in accordance with ISO 4309 which provides a procedure for undertaking an internal examination of a wire rope over a limited portion (**Figure 11**).
