Report on the investigation of the Grounding Incident involving

MV VISNES

15 February 2015

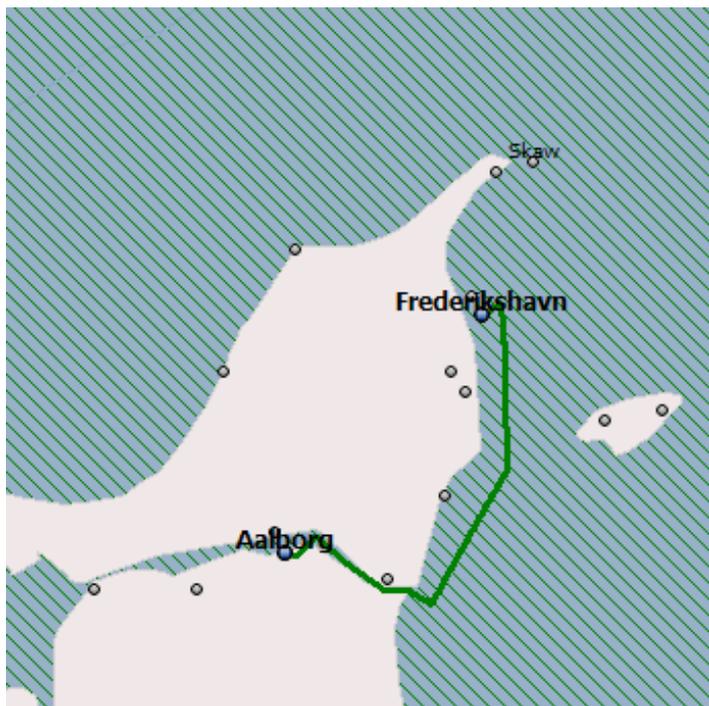
Photo Showing Major Damage

During the early evening of the 15th February 2015, the 1981 built, Gibraltar flagged, General Cargo Vessel, Visnes, IMO Number 7928251 struck an unknown, underwater object on her loaded passage from Thyborøn to Aalborg, Denmark. Bottom damage was suffered but the vessel remained in a safe, floating condition with a slight list to port that allowed her to proceed to discharge her cargo, and then make the onward short passage to the nearest shipyard at Frederikshavn.

The level of damage viewed on the ship ´s hull indicates the vessel struck a hard, more than likely heavy object, which could not have been easily swept aside.

The bottom damage is as follows from BV Class: Quote

WB DB PS 1/Center, Cropped out 100mm long in damaged area. 1 Centr. PS, bulkhead/sludge tk,
50mm long crack long.
